Tuesday, November 3, 2020

Indoor Air Quality Study

New York State Research and Development Authority
17 Columbia Circle
Albany, NY, 12203-6399

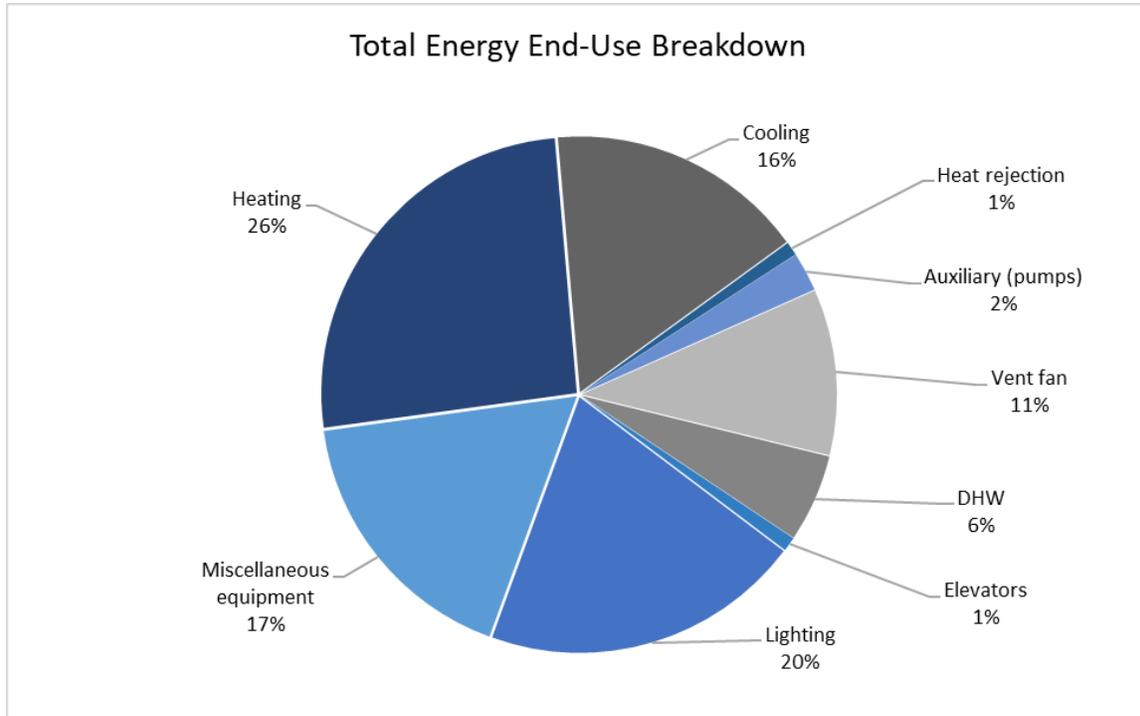
AKF developed an eQUEST energy model for 200 Park Avenue to simulate energy consumption at the facility. The model was calibrated using actual meteorological year for 2019 weather data, compared against the actual 2019 energy consumption for the building, to reflect energy consumption pre-COVID operational changes. The following chart present a preliminary energy end-use breakdown as generated by the energy model.

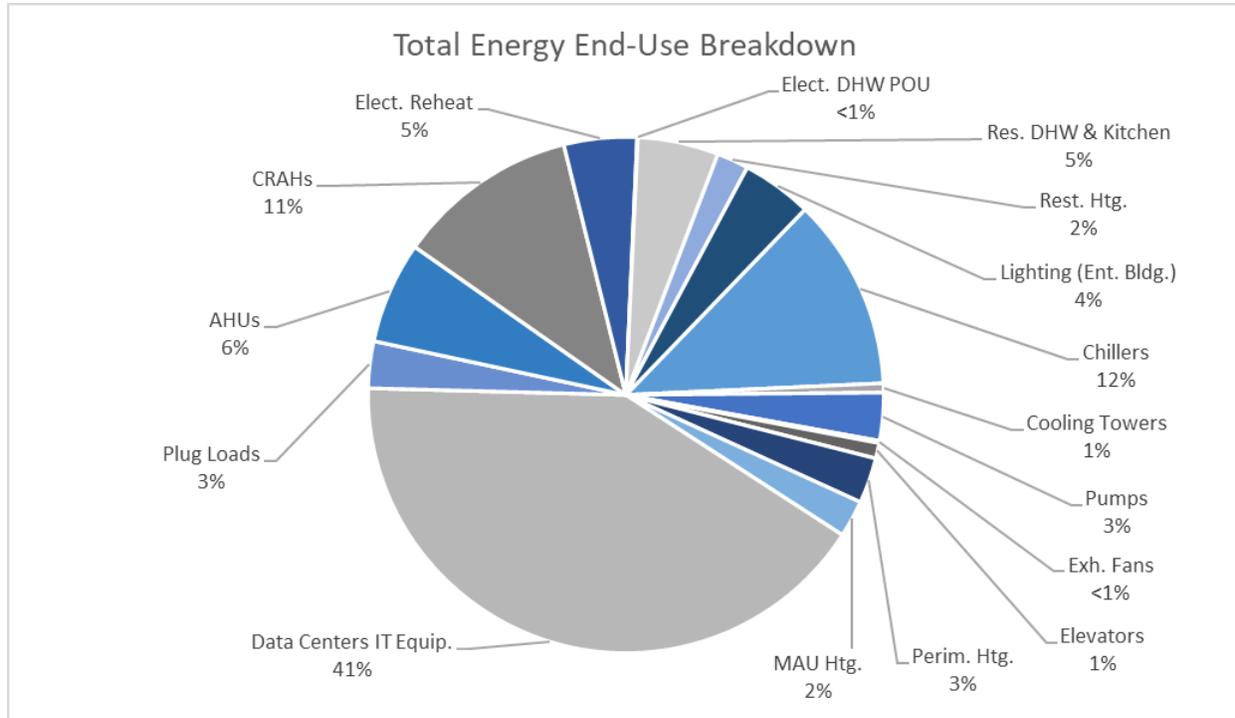
AKF developed an eQUEST energy model for the building to simulate energy consumption at the facility. The model was calibrated using actual meteorological year for 2019 weather data, compared against the actual 2019 energy consumption for the building, to reflect energy consumption pre-COVID operational changes. The following chart present a preliminary energy end-use breakdown as generated by the energy model.

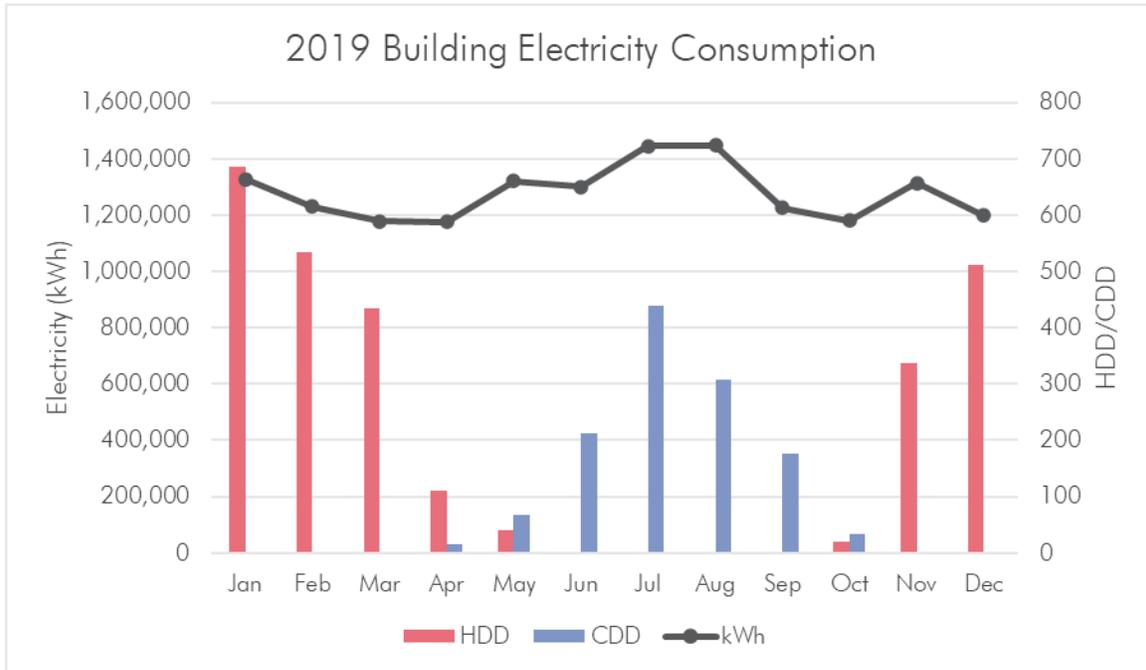
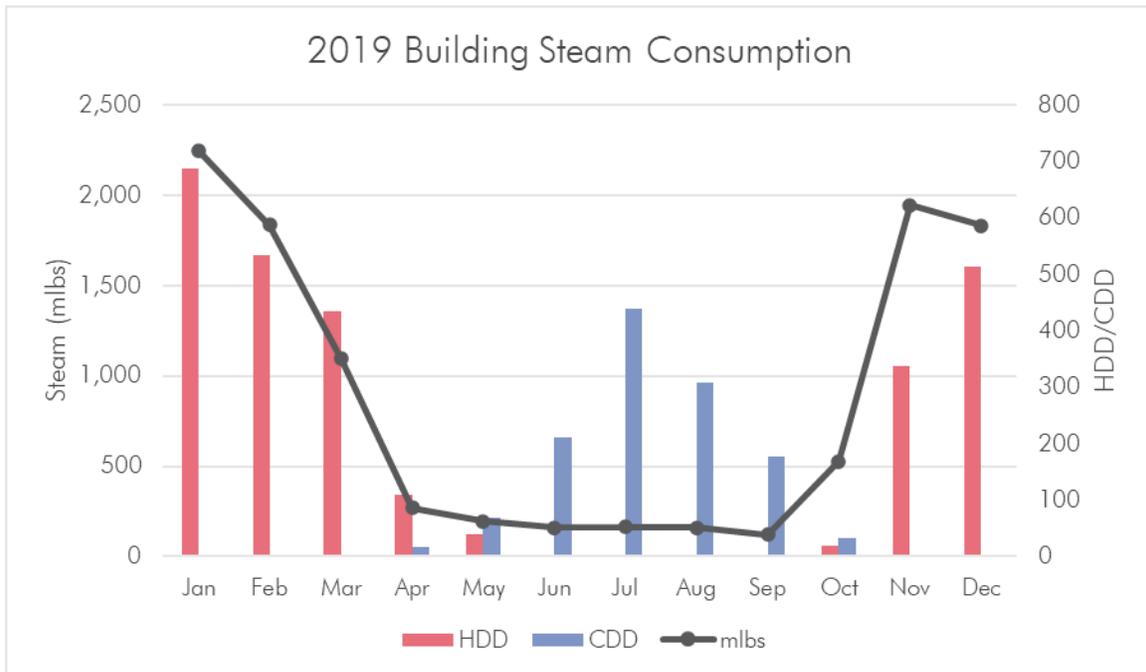
AKF has received access to the facility's EnergyWatch profile and analyzed the entire building energy consumption for 2019, the latest year of complete utility data not impacted by COVID operational changes. The following figures show the energy consumption at the facility.

Both the electricity and steam consumption profiles present a typical, weather-dependent usage, with a consistent baseline usage during the non-heating months. No atypical usage or spikes were observed. The following figure shows the total energy consumption at the facility for 2019.

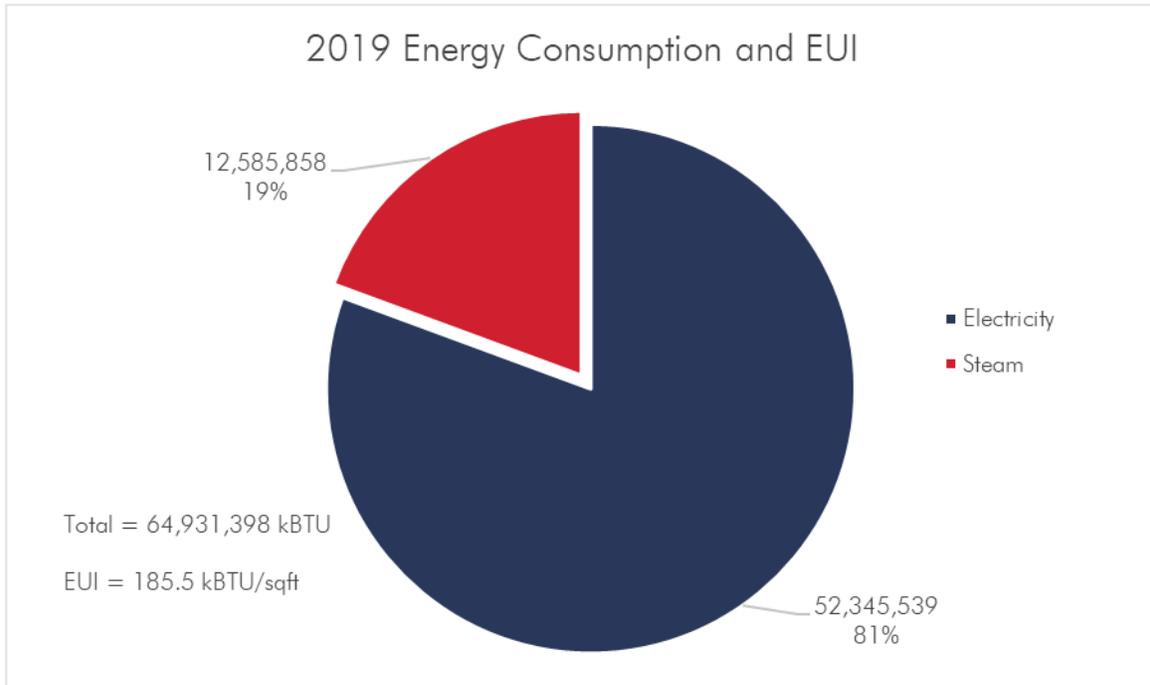
The facility presents a typical energy split between energy used for heating and electricity used for cooling and day to day operations at the building, with an EUI of 185.5 kBTU/sqft.

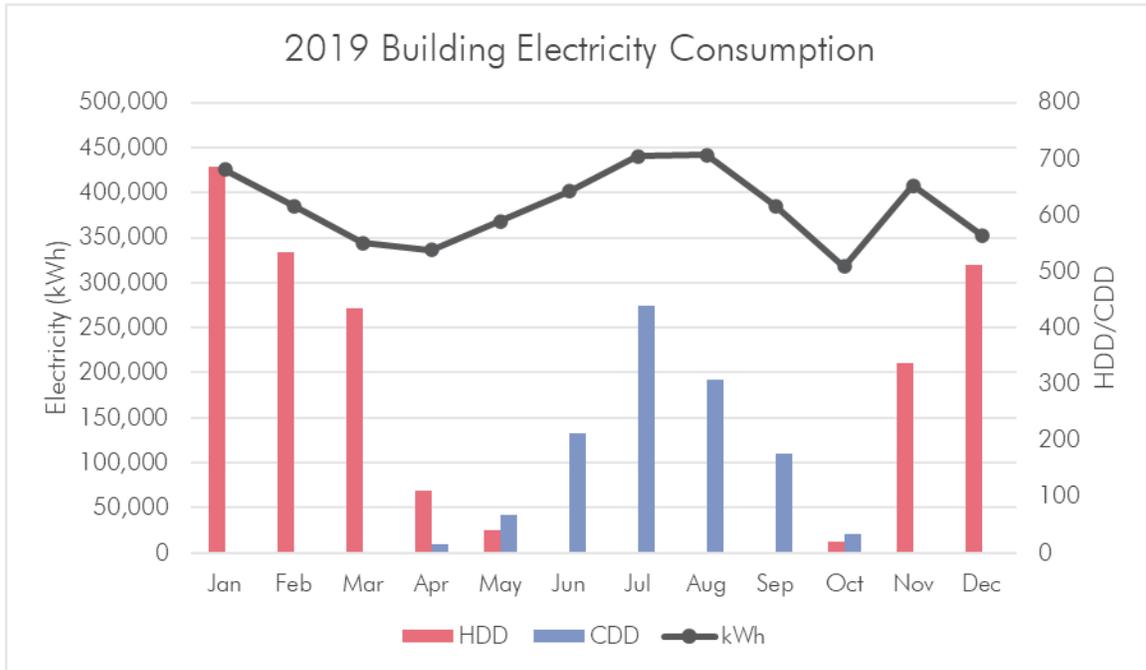
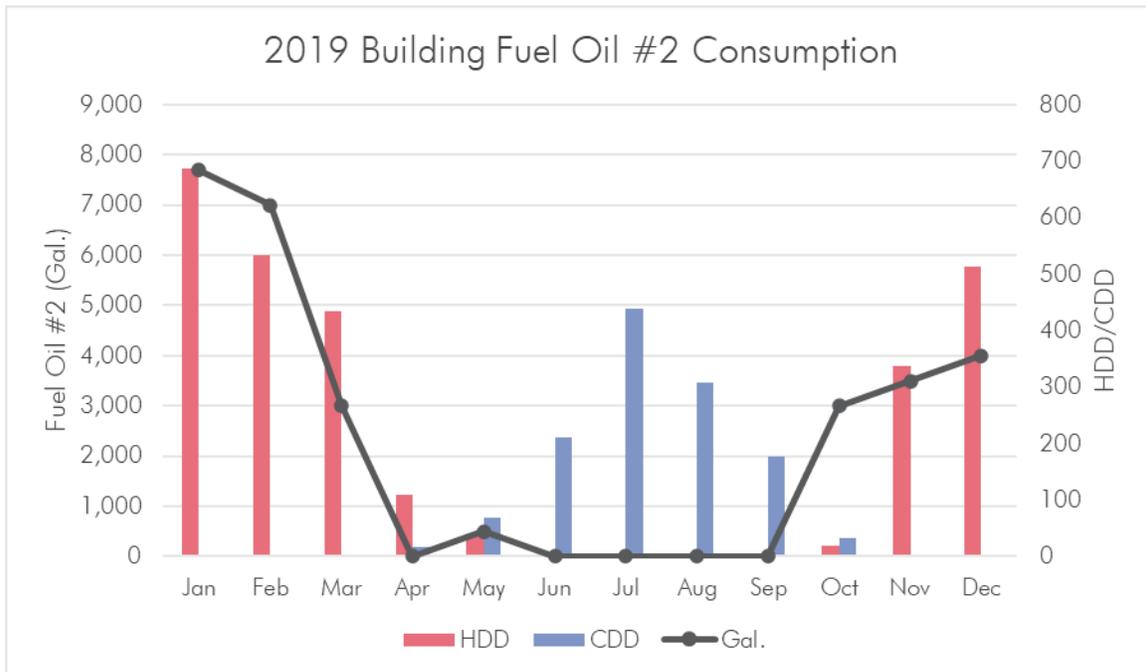
AKF has received access to the facility's EnergyWatch profile and analyzed the entire building energy consumption for 2019, the latest year of complete utility data not impacted by COVID operational changes. The following figures show the energy consumption at the facility.

Both the electricity and fuel oil consumption profiles present a typical, weather-dependent usage. No atypical usage or spikes were observed. The following figure shows the total energy consumption at the facility for 2019.

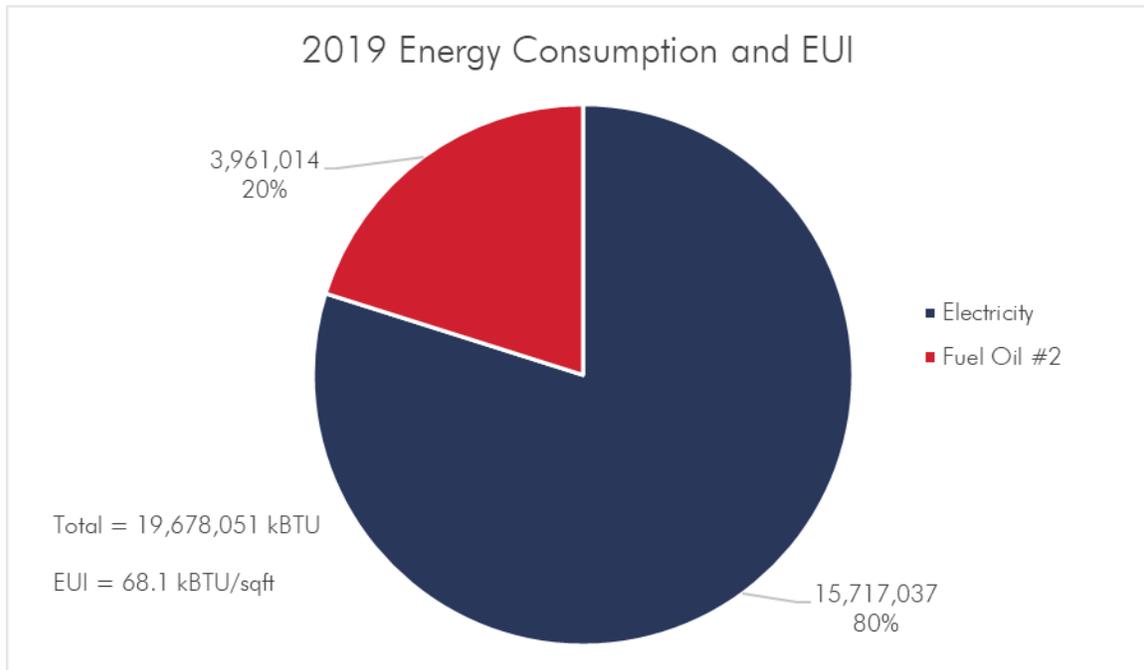
The facility presents a typical energy split between energy used for heating and electricity used for cooling and day to day operations at the building, with an EUI of 68.1 kBTU/sqft.
